# CTI 2500 Series<sup>®</sup> Controller INSTALLATION AND OPERATION GUIDE

Version 2.20

CTI Part # 062-00370

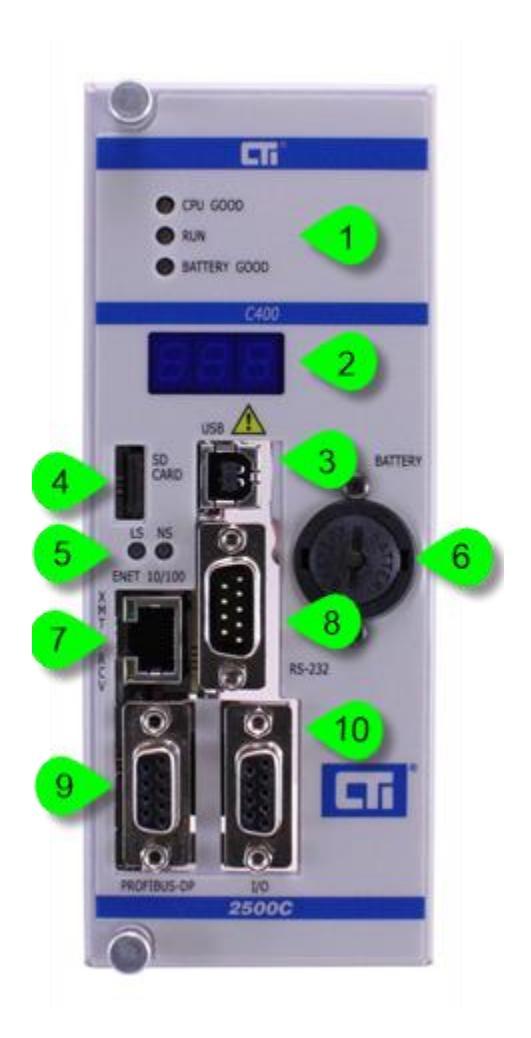
# 1.9 2500 Series Compact Controller Front Panel

### 1. Status LEDs

CPU GOOD RUN BATTERY GOOD

- 2. Multi-Segment Display` (MSD)
- 3. USB Port
- 4. SD Card Slot
- 5. Network LEDs LS – Link Status
  - **NS- Network Status**
- 6. Battery Holder
- 7. Ethernet Port XMT LED – Flashes when transmitting RCV LED – Flashes when receiving
- 8. Serial Communications Port RS-232/RS-422)
- 9. Profibus DP Port
- 10. Remote I/O Port

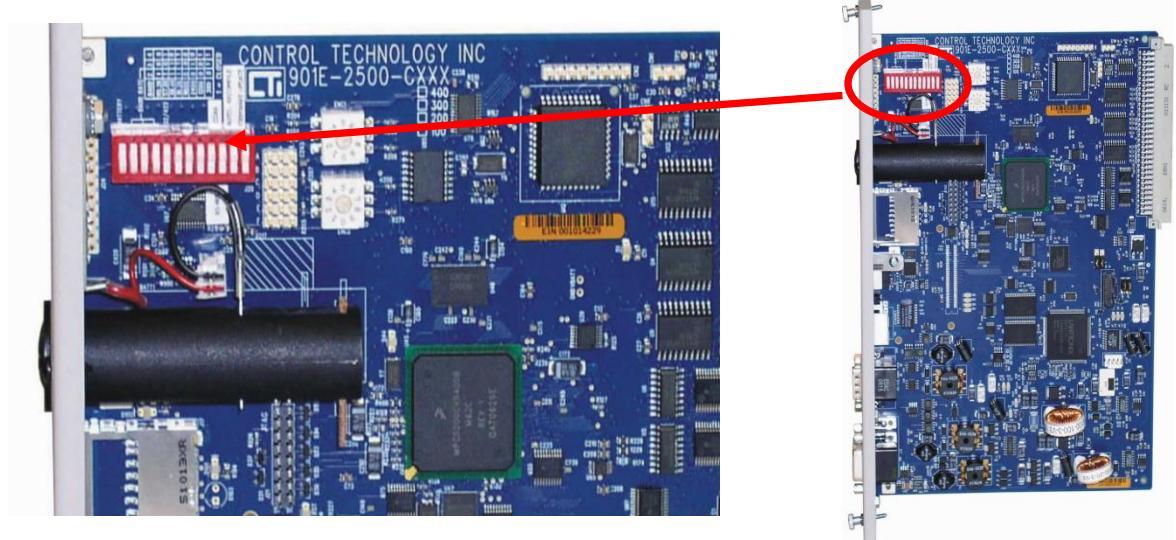
#### **CTI 2500 Classic Controller**

# 2.3.1 User Switch Locations

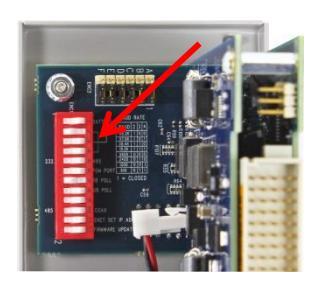
#### **CTI 2500 Compact Controller**

The switchblock containing the user switches is on the display board behind the front panel on the switchblock labelled ENC1. See accompanying picture.

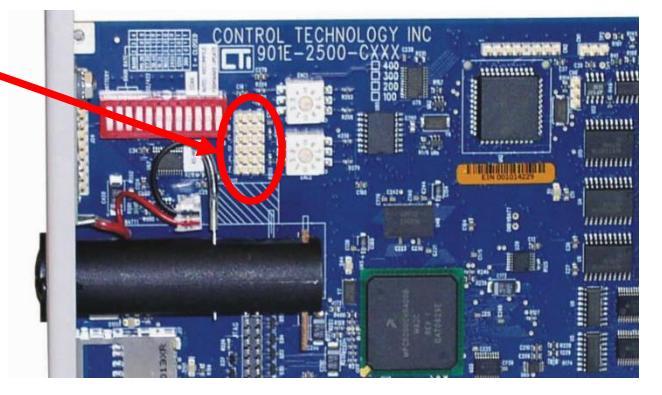
Similar in function to the user switches, user jumpers allow you to modify the operation of the controller. User Jumpers are labeled A - F. Jumpers are used instead of a switche where the modified behavior is not commonly used or to prevent the user from inadvertently selecting the modified behavior.

The user jumpers are located next

to the user switches (labeled as J20). A jumper is **OPEN** when the jumper is not installed or is located in the right hand position. A jumper is **CLOSED** when the jumper is in the left hand position. See the illustration below.

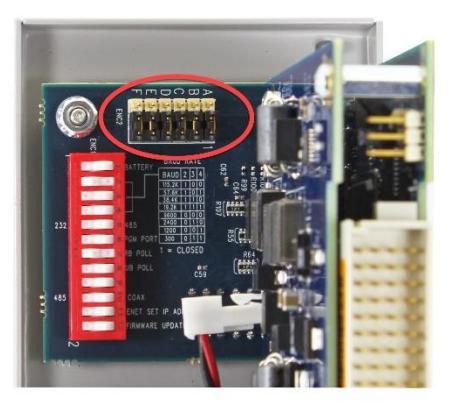
In the CTI 2500 Series Compact Controller the jumpers are located adjacent to the user switches as shown in the photo at the right. The jumpers are numbered 1 - 6. The **ON** position is equivalent to the **CLOSED** jumper position. In this photo, the jumpers are shown in the **OPEN** or **OFF** position.

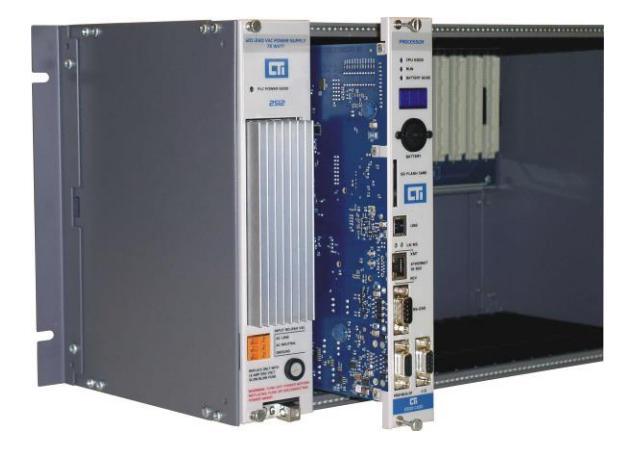
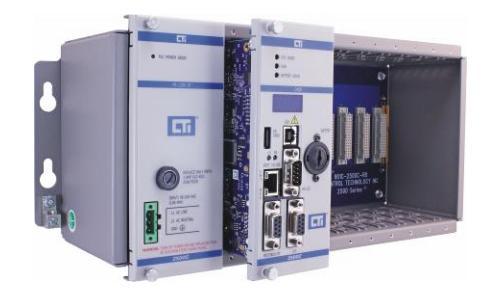
Remove AC power from the rack. Align the circuit board with the connector next to the power supply. Slide the controller into the rack until the connector seats. Use the thumbscrews to secure the controller in the rack.

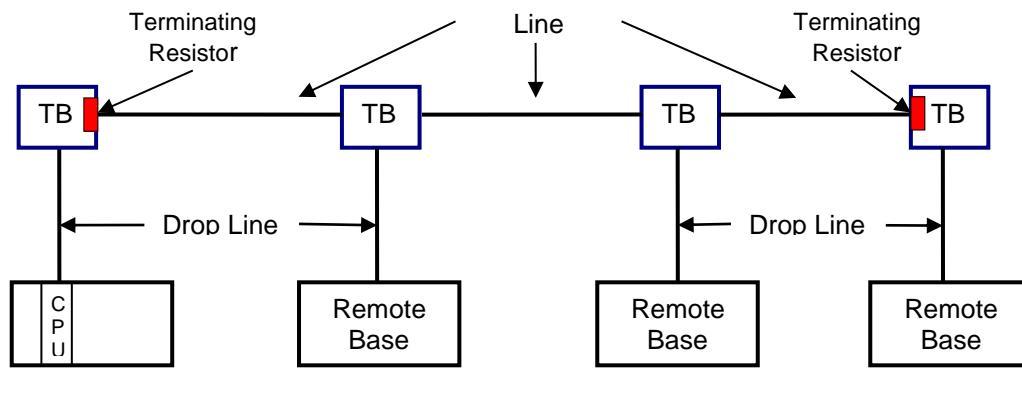
Remote I/O is connected to the CTI 2500 controller via RS-485 cable. Cabling is typically connected in a trunk line/ drop line arrangement as shown below.

TB = Terminal Block

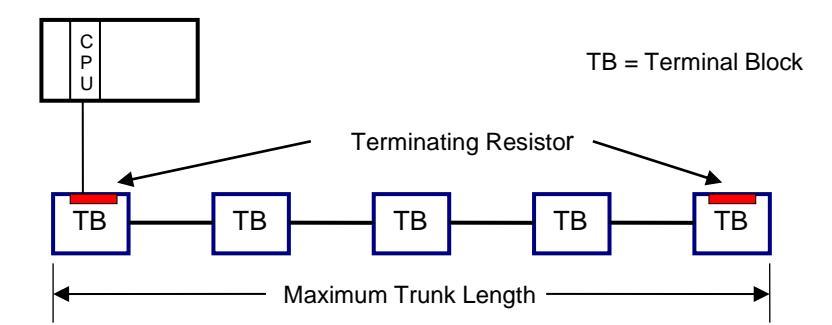
For each cable type, there is a maximum cable length. As the figure below indicates, the maximum cable length is measured from the CPU to the most distant tap. Note that a terminating resistor **must** be installed on the end terminal blocks.

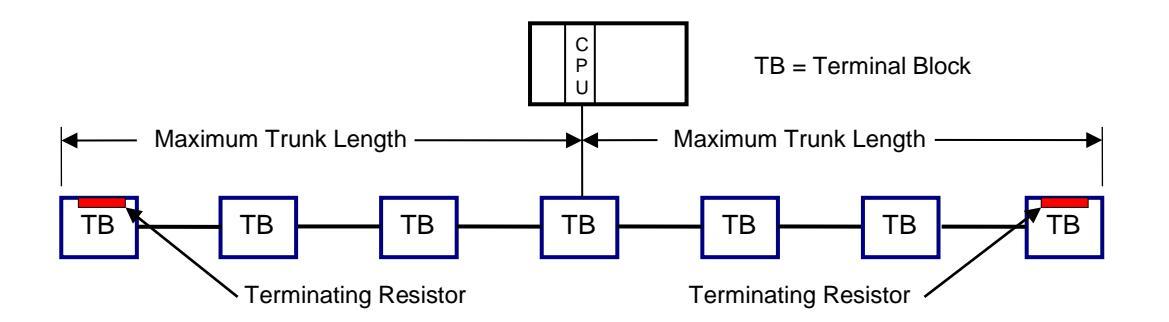
The maximum trunk length can be doubled by using a "T" topology as show below. Note the location of the terminating resistors.

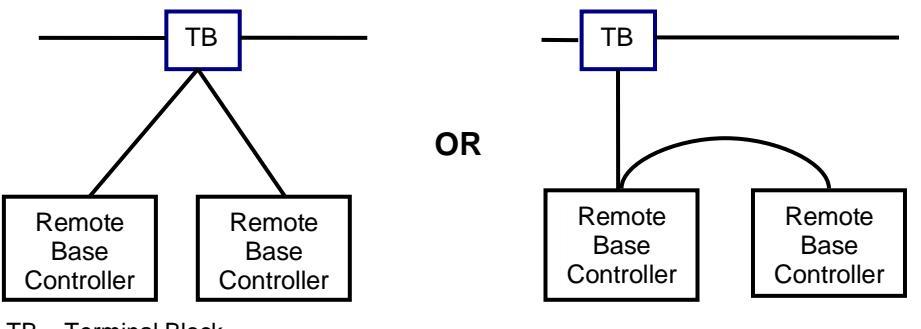
When multiple connections are required in close proximity, you should connect the equipment to a single terminal block instead of dedicating a terminal block to each connection. See the figure below for connection options.

TB = Terminal Block

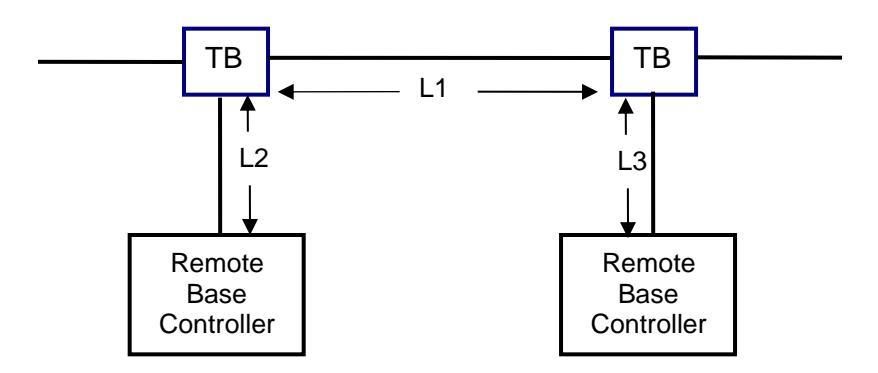
Terminal Block connections to the trunk line should be spaced so that the total length of the trunk line separating the taps is greater than the sum of the drop line lengths at the taps. In the illustration below, L1 should be greater than the sum of L2 + L3.

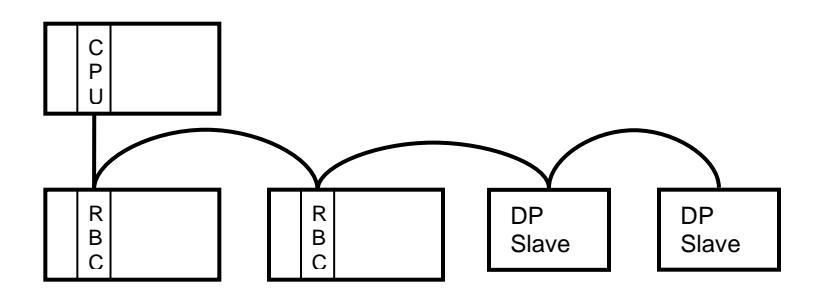
Profibus slave devices are connected in a "daisy chain" arrangement as indicated in the following illustration.

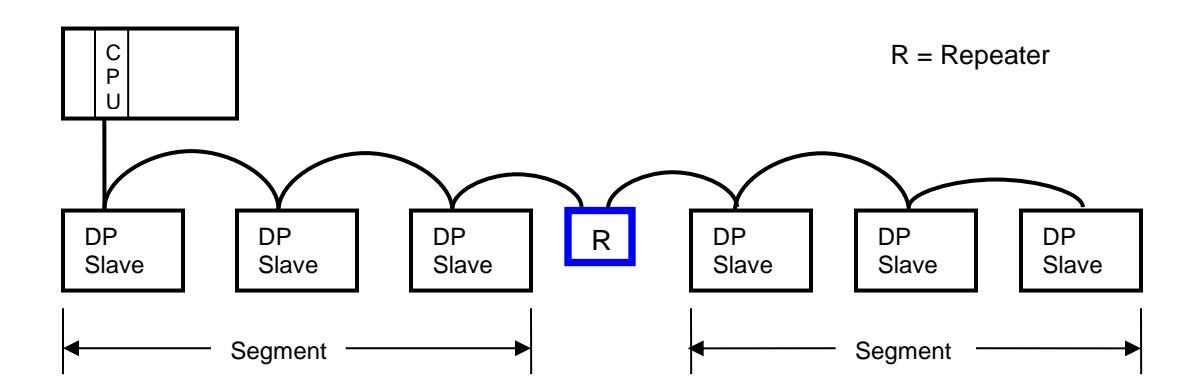
Up to 32 devices can be connected on a single segment. To increase distance or the number of devices supported, segments can be interconnected by using repeaters. Up to 10 segments may be connected together.

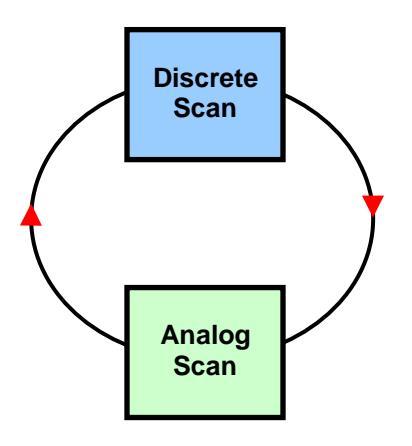
#### Figure 1. Controller Scan

The controller executes most tasks in a cyclical sequential order. This order is referred to as the controller scan. There are two major divisions to the CTI 2500 controller scan; the discrete scan and the analog scan. The discrete scan contains elements commonly found in traditional programmable logic controllers. The analog scan provides an execution framework better suited to process control tasks such as PID loops and analog alarms.

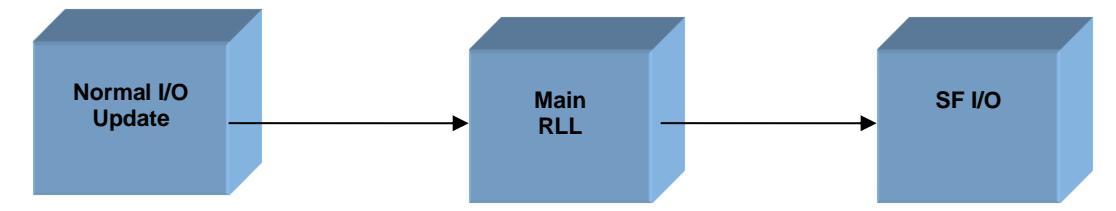
The discrete scan consists of three tasks. These tasks always run to completion.

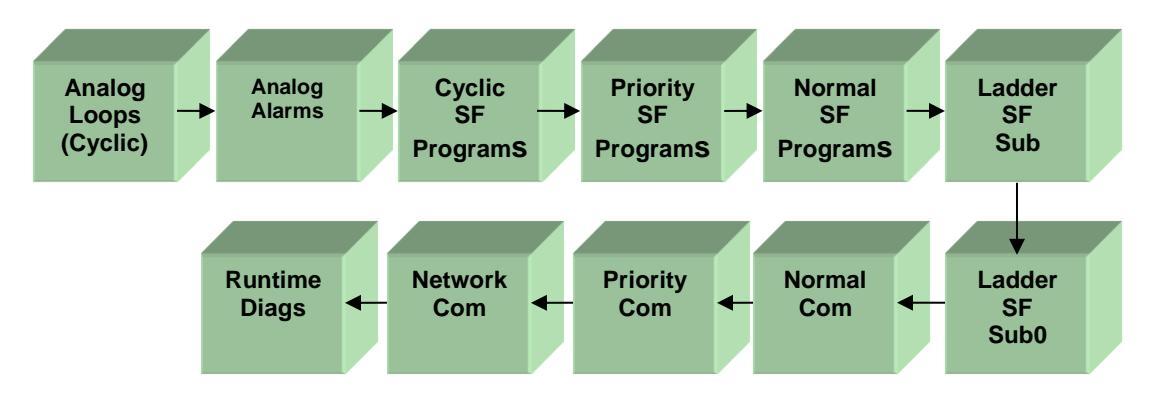
Each task in the analog scan is executed in a predetermined sequence. The controller will advance to the next task when nothing is queued for task execution or the time slice expires. When the time slice expires, the task will be suspended and will resume execution in the next scan.

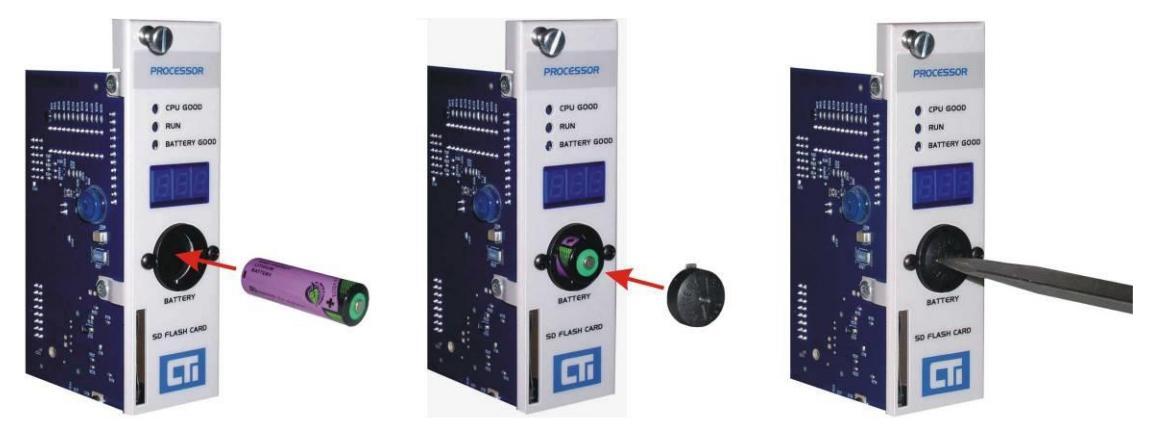
Remove these items from the bag. Insert the battery into the battery holder with the button end (+) facing outward. Align the battery cover tabs with the slots in the holder. Press the cover in until it is flush with the holder and rotate it 90° in a clockwise direction. You can insert a coin or a screwdriver into the slot on the cover to aid in rotating the cover.

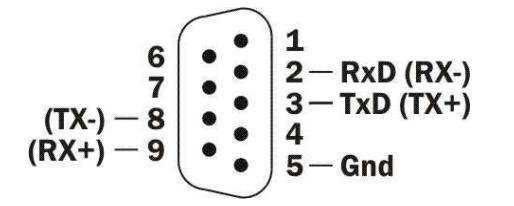
The serial port supports both the RS-232 and RS-422 electrical interface. The electrical interface in use is selected by a dipswitch setting (see Section 2.3). The cable used with the interface must connect to the correct pins used by the electrical interface. See the following pinout diagram for the serial port DB-9 connector.

Pin	Signal	Description
2	RxD	Received Data
3	TxD	Transmitted Data
5	GND	Signal Ground

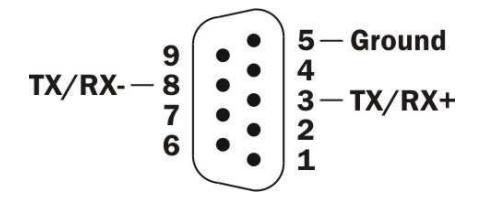
The figure below illustrates the pin connections of the DB-9 Remote I/O connector.

Connect the conductor without the shielding to pin 5 of the mating connector. Connect one of the color coded conductors to pin 8 and the other to pin 3. It does not matter which color you choose, except that you must be consistent throughout the remote I/O installation.

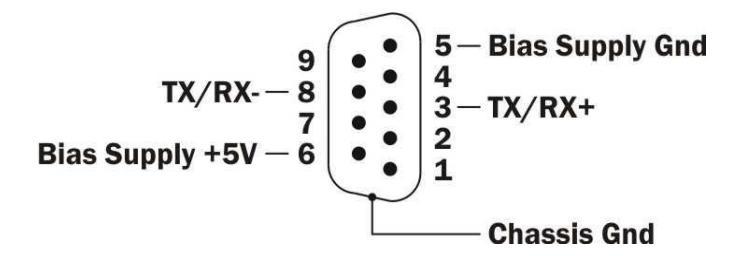
The following figure illustrates the pin connections of the Profibus DP DB9 connector. The TX/RX + and TX/RX - wires are connected as shown. The cable shield is connected to Chassis Ground. Pins 5 and 6 are used for the bias circuit.
